Causes and Remediation of Corrosion Failure of Duplex Stainless Steel Equipment in a PVC Plant

Dr. Michael Davies, CARIAD Consultants, and Gerhard Potgieter, Polifin Group Engineering

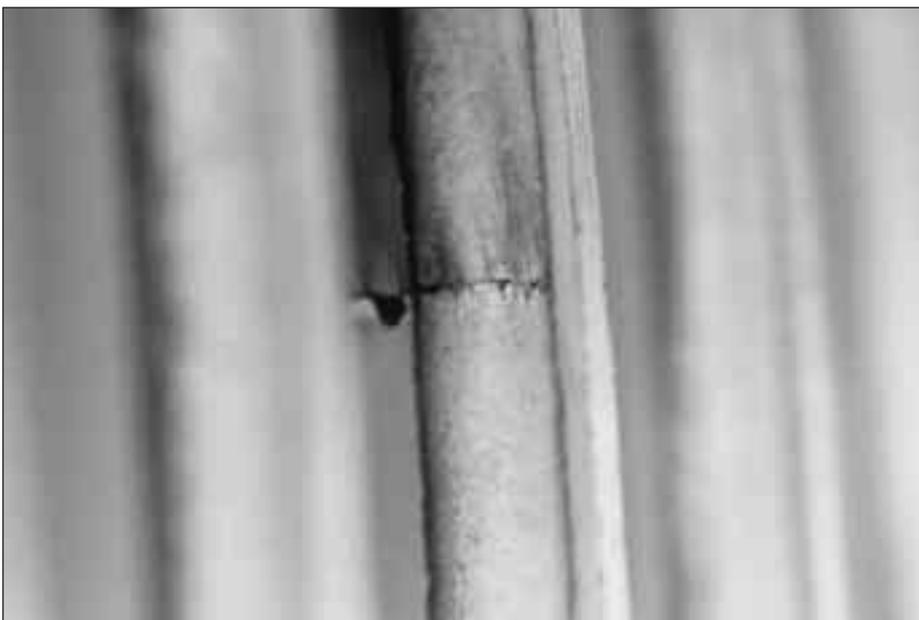
Visual examination of the two exchangers detected 10 cracks on unit A and 5 cracks on unit B. Numerous pits were also observed on both units and the cracks were often initiated at corrosion pits, welds and locations where weld spatter was present on the surface. All cracking was on the hot side of the exchangers, none on the cold side. Crack length was up to 29 mm on unit A and 20 mm on B. Replicates taken of some of the cracks did not show branching. The spacer pins, which separate adjacent sheets of the exchanger, were also seen to be cracking and corroding. These pins were also 2205 and were attached by CDSW (Capacitor Discharge Stud Welding). It was concluded that neither of the exchangers could be repaired and both should be replaced. A typical crack across a weld is shown in Figure 2.

Figure 2.
Crack across weld in spiral heat exchanger.

Since the equipment was still in operation it was not possible to cut out sections to carry out exhaustive metallurgical examination which could determine the precise corrosion mechanisms operating. However, based on consideration of the process conditions, together with results of the inspection, it is probable that the mechanism was chloride stress corrosion cracking (SCC) combined with chloride pitting.

d) Weld spatter on the hot side of the exchangers also promoted attack. Spot welds, tack welds and weld spatter are detrimental to the corrosion behaviour of duplex alloys because of their rapid cooling and higher ferrite content formed.

Both exchangers needed to be replaced. If the same material were to be used then the operating conditions would need to be altered to make the environment less aggressive to this duplex alloy. If the operating conditions were kept the same then a more resistant material would be required for the replacement exchangers. Both of these approaches were investigated.

Since the plant could not operate continuously and consistently under conditions that would ensure no appreciable corrosion of 2205 it was decided to upgrade the materials of construction for the replacement heat exchangers.

Based on these results and prior experience it was recommended that the replacement exchangers should be fabricated from 254 SMO with I 625 spacer pins. In fact, both candidate alloys were used with 254 SMO in the hottest sections and 1925 hMo for the remainder. Quality assurance procedures were improved to eliminate the variability of adhesion and reinforcement found in some of the test pieces. Some changes were also made in the design of the spiral exchangers. The central inlet was modified changed to incorporate a patented design that gives better velocity distribution,

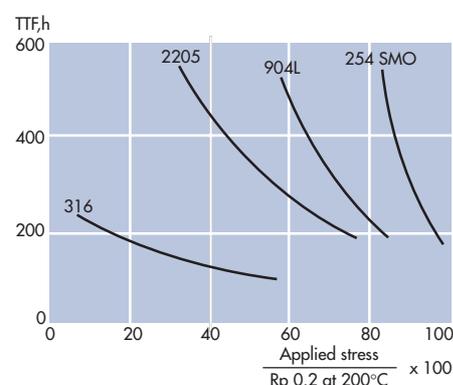
Figure 3.

Comparison of SCC behaviour of 2205 and 254 SMO (3).

data from the NaCl drop evaporation test compare time to failure (TTF) in hours with applied stress levels for various alloys. These data are a bit misleading since the applied stress is related to the proof stress which is

higher for 2205 than for the austenitics. Allowing for this strength factor would reverse the order of 2205 and 904L in this curve but 254 SMO would still have a longer TTF than the other two alloys.

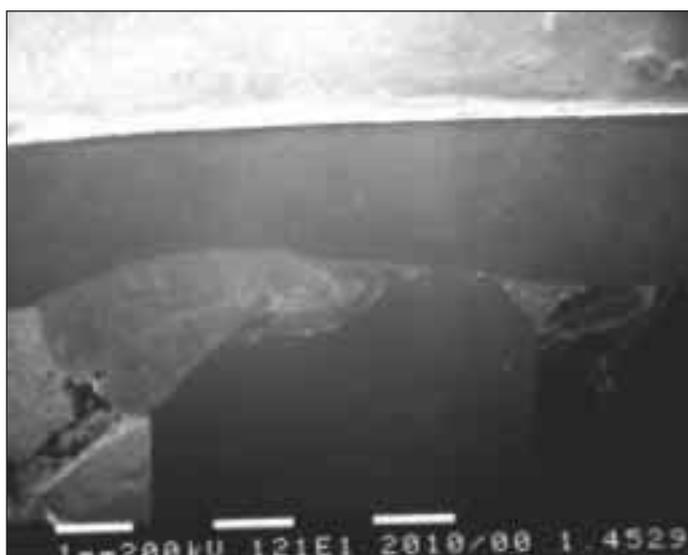
Figure 4. Section through sample of 1925 hMo plate, weld and I 625 stud.

The weld profiles were irregular in all four samples examined, see for example 1925 hMo in Figure 4. At higher magnification no gross precipitation was evident in the weld area. There was, however, some lack of bonding at the plate-weld interface in some areas. This weld profile variability and lack of bonding was not dependent on the shell material, (see Figure 4).

The SEM examination showed no appreciable segregation of molybdenum or chromium. This correlates well with the pitting resistance behaviour. Lack of fusion at the edge of the stud welds was observed in some of the samples. This seemed to be related to the positioning of the stud over the plate prior to welding. Further evidence for this effect was found in the difference in weld reinforcement from one side of the stud to the other.

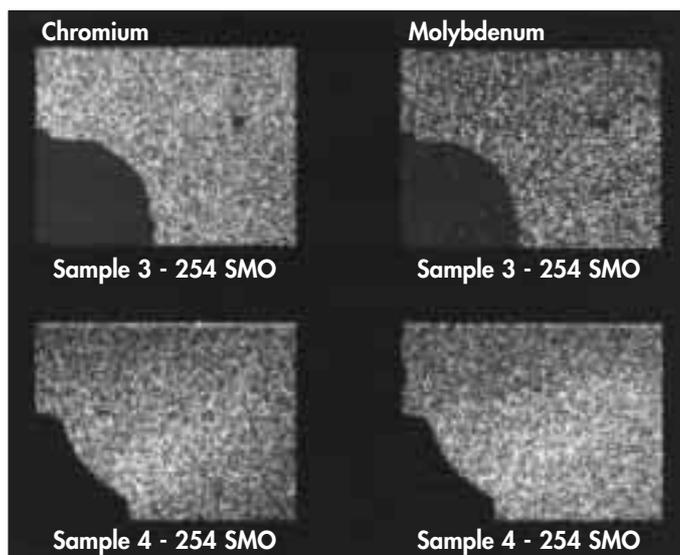
Figure 5. Digital X-ray map of 254 SMO showing distribution of chromium and molybdenum in 2 samples. The plate material is at the top of each image.

X-ray analyses were carried out on stud, shell and weld material. Digital X-ray maps were also produced at low magnification to cover all areas of the sectioned joint (Figure 5). These analyses did not detect any areas of depletion or concentration of the key alloying elements in the weld or heat affected zone. No alloy-rich precipitated particles were detected (see Figure 5).

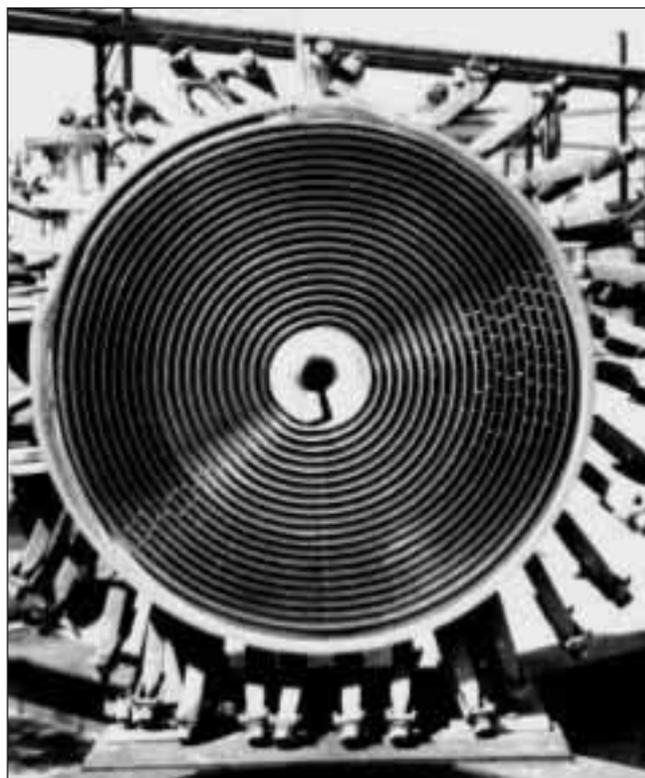
Figure 6. Replacement spiral heat exchanger in 6% molybdenum austenitic stainless steel.

eliminates dead spaces, produces less fouling and makes the exchangers easier to clean. One of the replacement exchangers is shown in Figure 6.
