## Microbiologically Influenced Corrosion

# MIC on Stainless Steels in Wastewater Treatment Plants

## Field Tests and a Risk Assessment

# Service Experience with High Performance Stainless Steels in Aggressive Fresh Waters

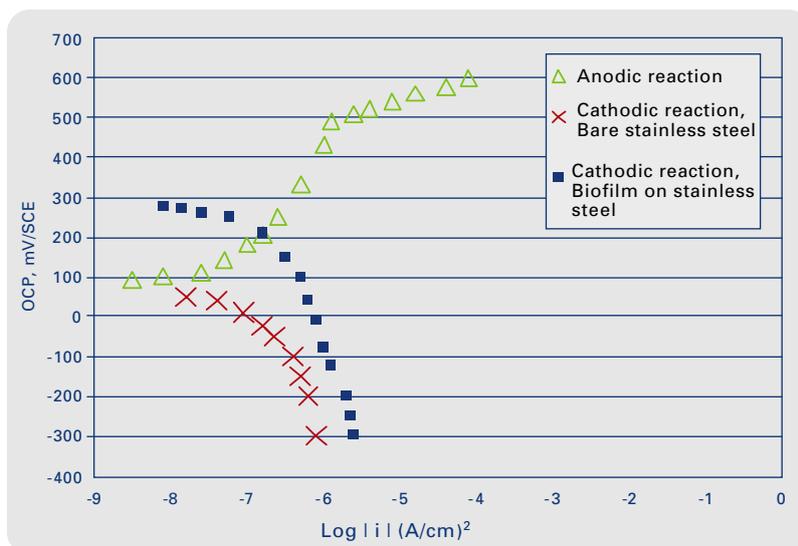
**Fig. 1** Schematic view of the cathodic reaction, which is influenced by biofilm activity.

linking oxygen reduction depolarization, biofilm growth and potential for stainless steels exposed to natural seawater [8]. They concluded that oxygen depolarisation of a stainless steel surface was due to the formation of localized active sites. These sites were attributed to the covering or adsorption of bacteria or bacteria-produced catalysts, on the metal surface, which reduced oxygen with fast kinetics. Figure 1 shows schematically how the overall cathodic reaction is influenced by the activity of the biofilm.

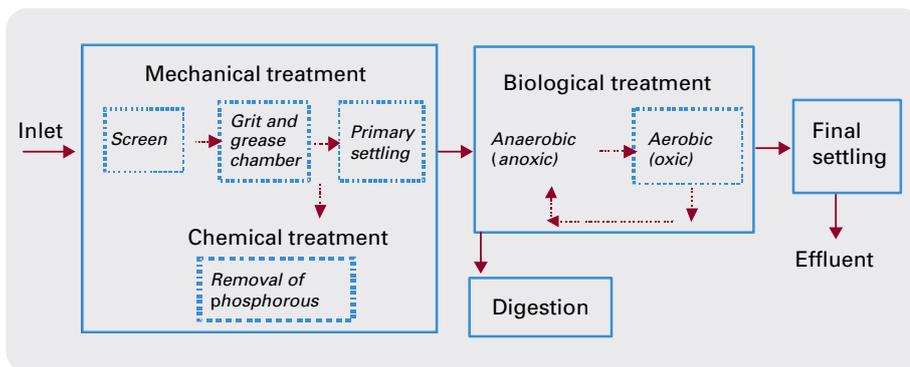
**Fig 2.** Schematic view of the main processes in a wastewater treatment plant.

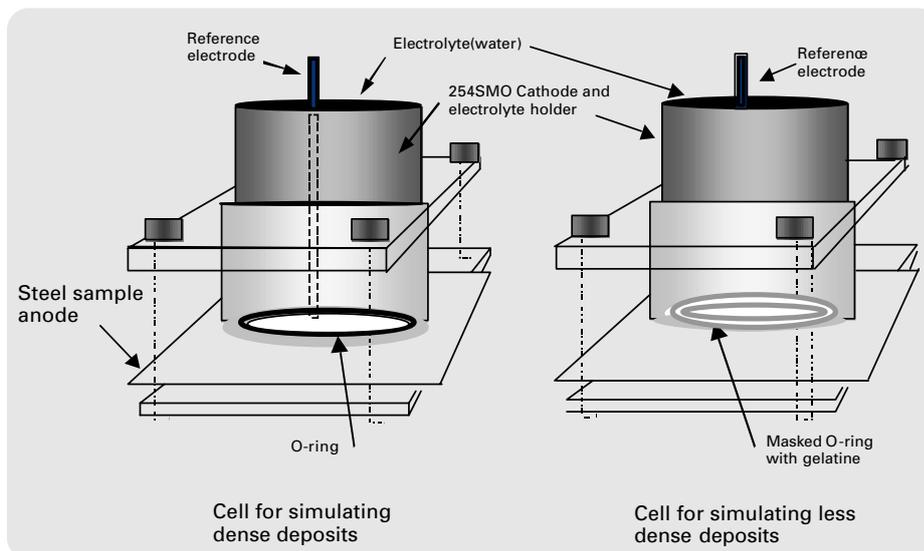
Fig. 3 Electrochemical cell used to simulate deposits on the steel surface.

The stainless steel grades shown in Table 1 were also investigated in the laboratory, however, no welds were exposed in the laboratory tests. Anodic polarization curves were recorded using an electrochemical cell, as shown in Figure 3, chosen for its capability to provide conditions similar to deposits on a stainless steel surface or in shallow crevices. The electrochemical cell was used to simulate two kinds of deposits on the surface, (one kind using the o-ring as more dense deposits and the other masking the o-ring with gelatin for simulating less dense deposits). The breakdown potential was measured for all steel grades in the cell with the two kinds of deposits. For both events the breakdown potential was noted from anodic polarization curves when the localized corrosion current density exceeded  $10 \mu\text{A}/\text{cm}^2$  for more than one minute. A factorial design was carried out at maximum and minimum values for various amounts of chlorides, sulfates and nitrates based on the values found in six wastewater treatment plants. The design was carried out to find a risk assessment for stainless steel grades used in Swedish wastewater treatment plants. Table 2 shows the minimum and maximum values of chlorides, nitrates and sulfates used in the factorial design [24].

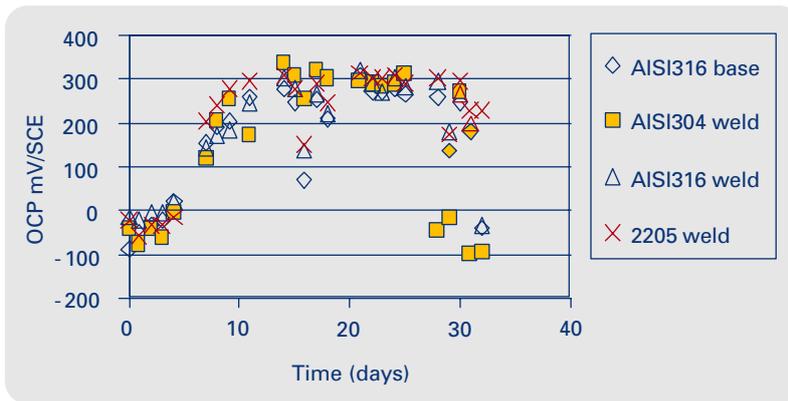
**Fig. 4** Time dependence of OCP during exposure of AISI 304, AISI 316 and 2205 coupons in the final stage of wastewater treatment plant 1 (aerobic biodegradation of wastes).

In aerobic conditions (e.g., COD values ranging from 4–7), the potential increased between 190 mV/SCE to 340 mV/SCE, whereas, in more anaerobic conditions (e.g. COD values higher than 7), the OCP increase was low and even decreased at higher COD values. The increase or decrease in OCP of stainless steel was independent of parameters such as the composition of the stainless steel grade, on the surface oxide composition, weld or unwelded conditions, with or without pickling the weld oxides, and on the microstructure of the steel, (i.e. austenitic or duplex stainless steel) as shown in Figures 4 and 5. The large oscillations in the OCP measured after 15 and 30 days exposure in the final stage of the wastewater treatment of plant 1, (Figure 4), are probably due to the initiation and the repassivation of pits.

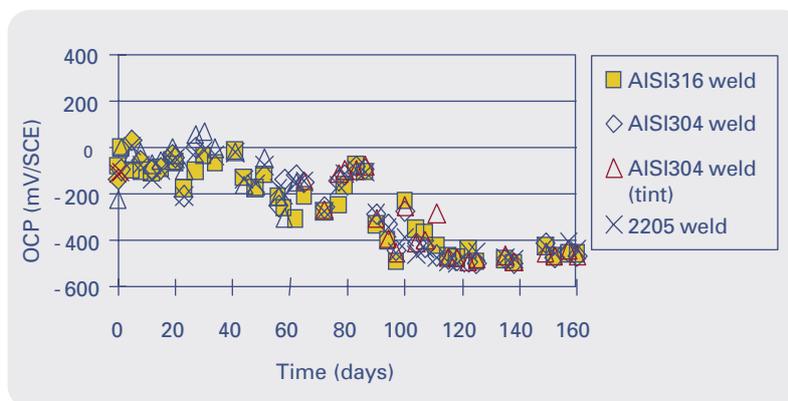
**Fig. 5** Time dependence of OCP during exposure of AISI 304, AISI 316 and 2205 coupons in the final stage of wastewater treatment in plant 5 (anaerobic biodegradation of wastes).

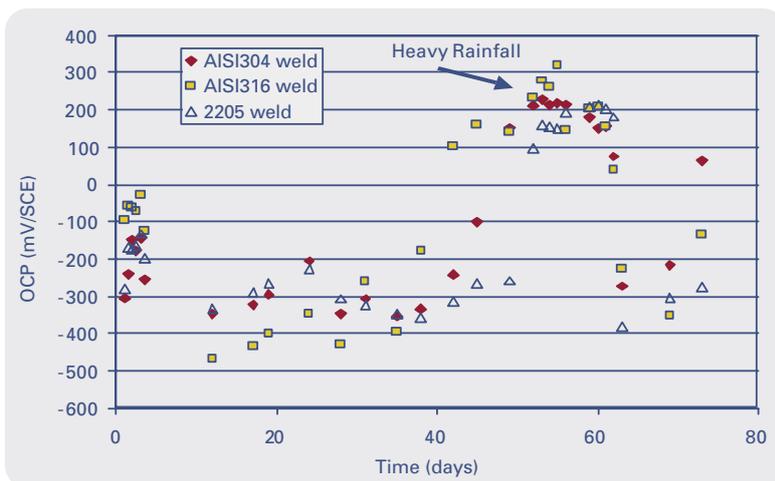
**Fig. 6** Time dependence of OCP during exposure of AISI 304, AISI 316 and 2205 coupons in the final stage at wastewater treatment plant 6.

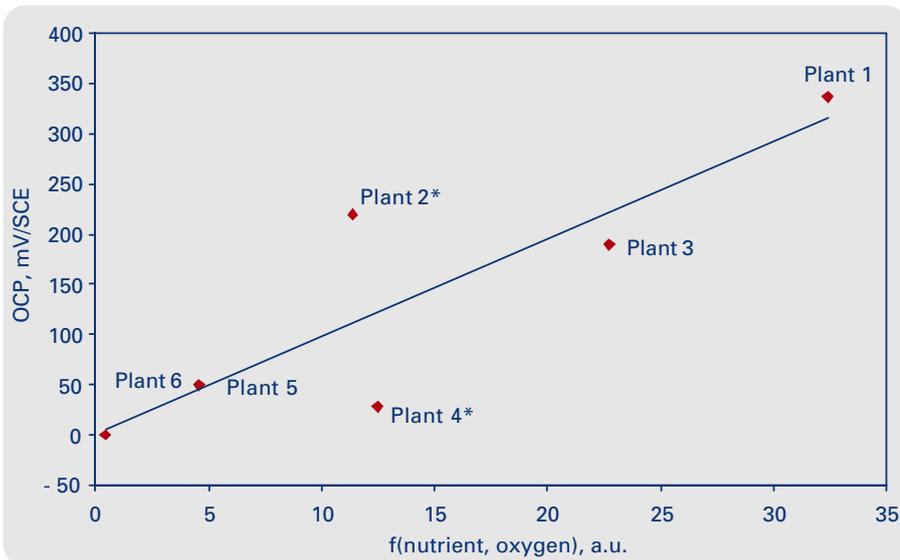
**Fig. 7** Maximum OCP measured on stainless steel in the final stage of wastewater treatment plants as a function of nutrients and oxygen content in the water (see equation 2.)

The importance of nutrients and oxygen content on the ennoblement of the OCP of stainless steel can be seen in Figure 7. An empirical function representing the influence of the amount of nutrients and the oxygen content has been defined using data from this investigation:

From the results, it is obvious that there is a relationship between the nutrient and oxygen content in the water and the ennoblement of the OCP of stainless steel. However, it should be noted that the function defined in equation 2 is empirical and other parameters such as the temperature, carbon, potassium and phosphorus content may play an important role in the development of the biofilm [1].

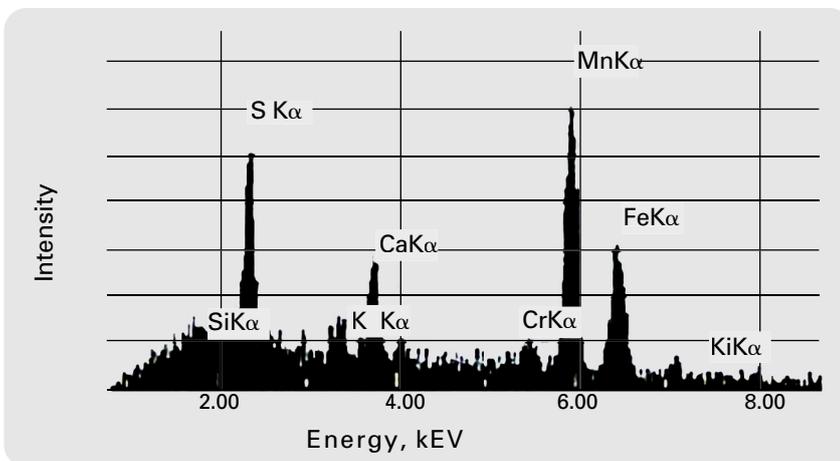
**Fig. 8** SEM/EDS analysis of the deposits found on AISI 316 after a year field test at plant 1.

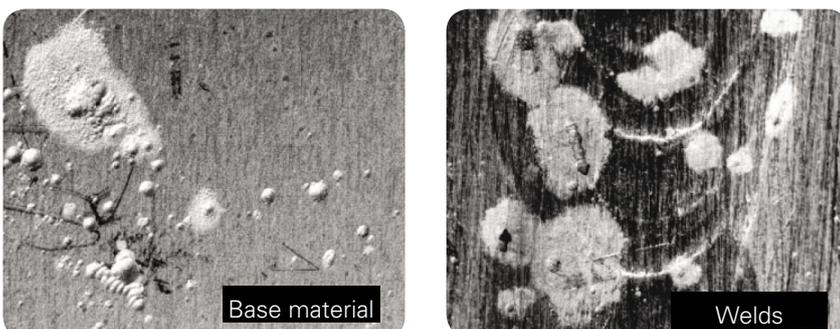
**Fig. 9** Localized corrosion found on AISI 316 under heavy deposits after a field test at plant [1]. (magnification x3)

At plant 1, corrosion was found on stainless steel grades AISI 304 and AISI 316 in combination with heavy deposits, a high chloride content and ennoblement. Figure 9 shows the extent of corrosion on the base material and on the welds of steel grade AISI 316 after removal of the deposits.

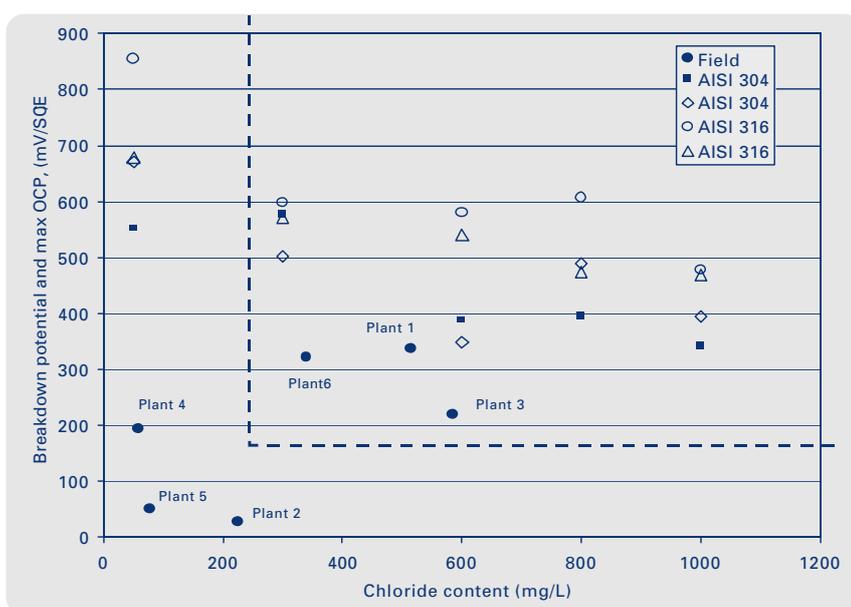
**Fig. 10** Breakdown potentials of AISI 304 and AISI 316 providing a risk window in wastewater treatment plants, where a microbiologically active biofilm causing ennoblement is attached to the stainless steel surface. The results from field tests are indicated.

Using statistical methods, it was shown that the chloride content was the major parameter influencing the initiation of localized corrosion on AISI 304 and 316. Based on these calculations, experiments were carried out excluding sulfates and nitrates for a risk assessment design to cover the worst case scenario. A risk window for MIC in wastewater treatment was designed for clean water and with the addition of chloride ions. Figure 10 shows the risk window for standard steel grades AISI 304 and AISI 316 as a function of the chloride content. The figure shows the breakdown potentials for parallel samples of the two steel grades. For potential above the breakdown potential, the risk of localized corrosion increased. The upper limit of the window is not defined since it is based on the probable potentials received with addition of oxidative chemicals.

The lower limit of the window has been defined from real plants in order to be below the risk of initiation of localized corrosion. Hence, the role of the biofilm may be to raise the potential at values within the window. This was the case for coupons exposed to treated wastewater at plant 1. It should be noted that the exact definition of this window depends on the temperature and whereas the material is used as base or welded conditions.

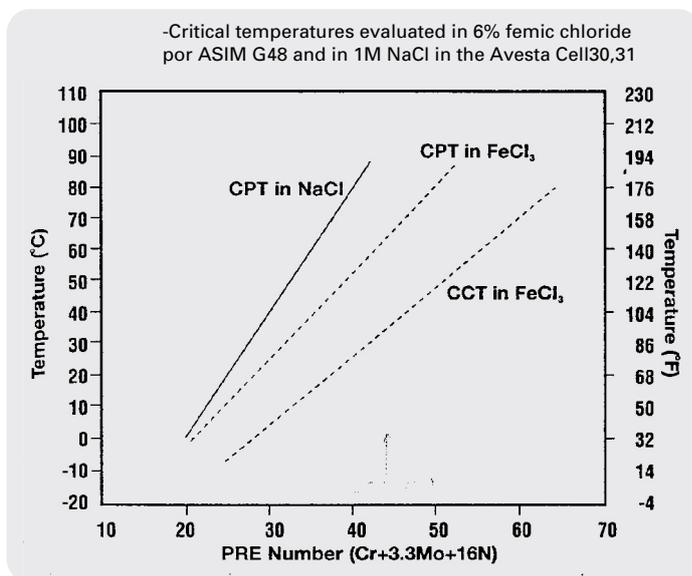
**Fig. 1** Critical pitting and crevice corrosion temperatures for austenitic stainless steel related to PRE numbers

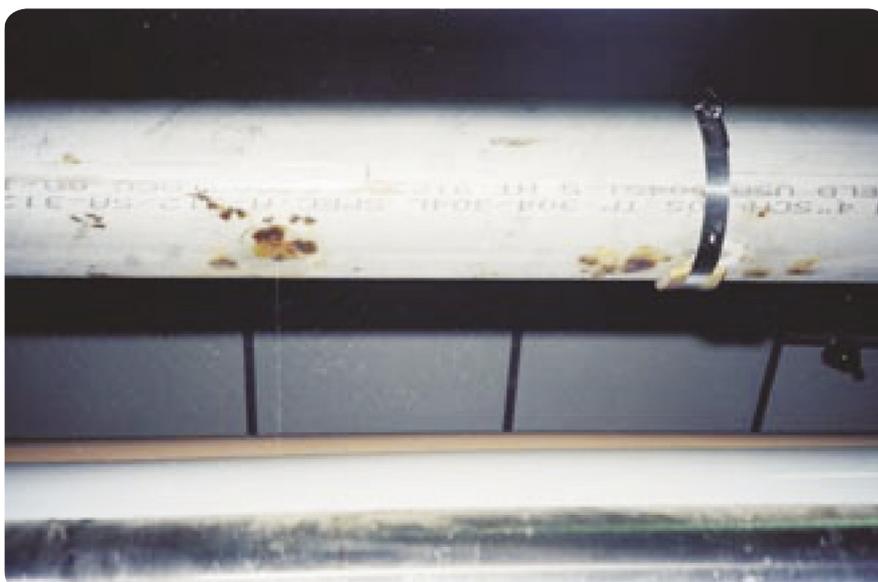
**Fig. 2** Insulation removed from hot water pipe. A patch intended to temporarily fix a leak is visible on the right.

A food processing plant uses water from its own well as a food ingredient. The water is pre-chlorinated and passed through a green sand/carbon filter and pumped into a reservoir outside the plant. All piping outside the plant is made from carbon steel or cast iron. From there the water is chlorinated again and brought into the plant. A Type 316 stainless steel heat exchanger heats the water to 150°F. The water is carried into the food processing area by an overhead “hot water line”. The insulated line is about 2,000 feet long and was originally built in Type 304 stainless steel. It has a main header of Type 304, 4-inch diameter schedule 10 pipe (0.12 inch wall thickness). At the far end of the insulated water line, the water temperature decreases to 80 – 120°F. After less than two years of service, the smaller diameter piping of the hot water line began to leak. Within five years, leaking was evident along the entire line. Figure 2 shows a picture of the pipe that has been temporarily repaired with patches.

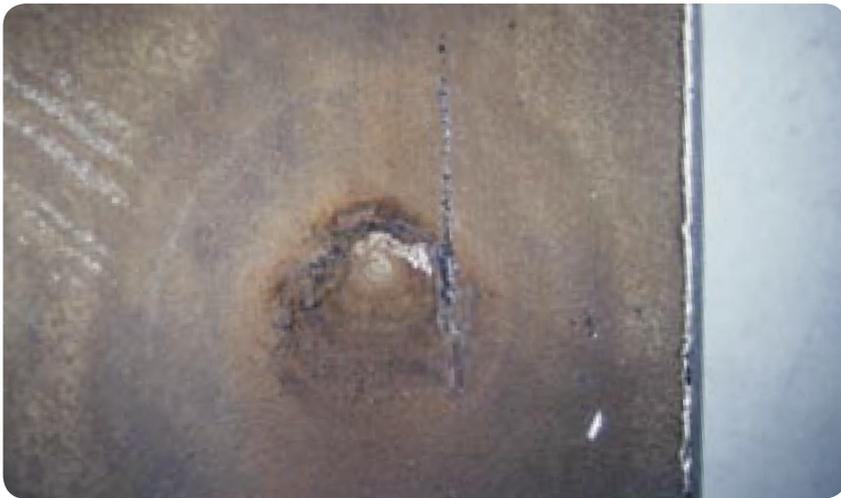
**Fig. 3** A through-wall pit. The area directly at the pit mouth is blank metal surrounded by a dark stain.

ID of the pipe. The pits were usually surrounded by a dark stain aligned with the flow direction of the water and a clean-etched area immediately at the mouth of the pits (Figure 3). SEM-EDAX analysis of the material within the mouth of a pit showed very high manganese contents compared to the manganese content of the deposit and in the stainless steel.

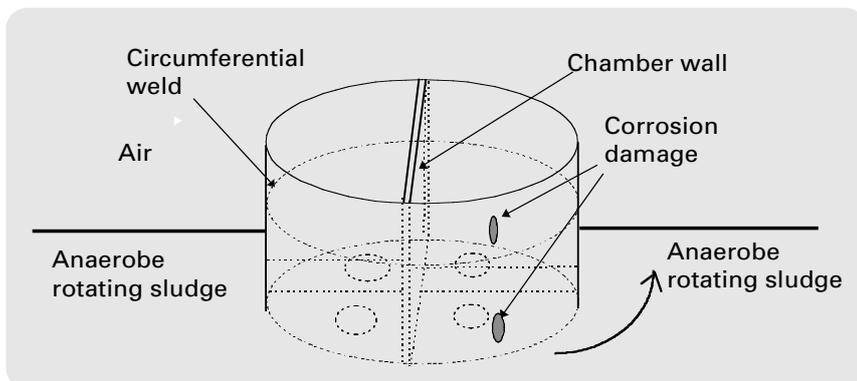
**Fig 4.** Schematic View of Corrosion Damage on the Outside of a Gas Seal on the Top of a Digester at a Wastewater Treatment Plant.

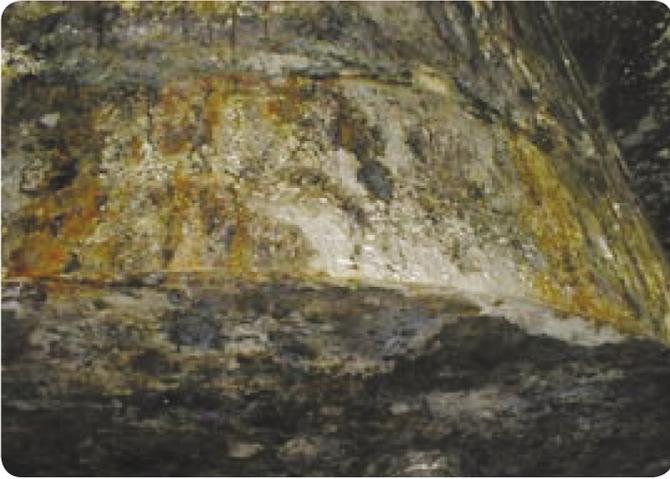
**Fig. 6** Corrosion Damages on the Gas Seal

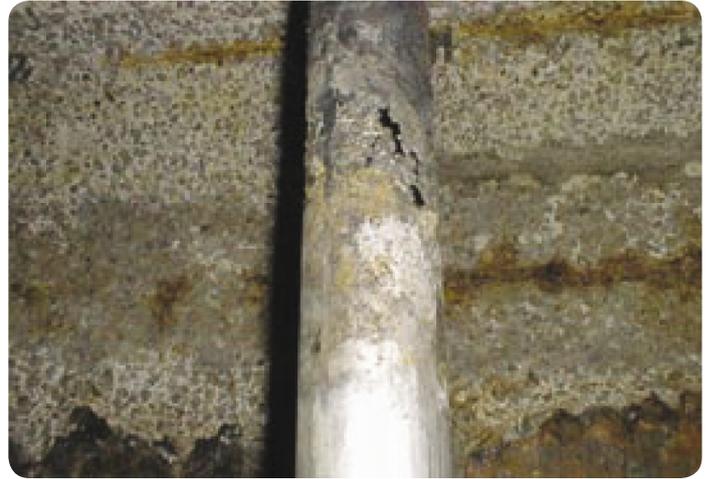
**Fig. 5** Perforated Pipe Attached to the Gas Seal

the inside where the water/gas seal was facing sludge under digestion under assumed anaerobic conditions. Figure 5 shows corrosion damage from the inside of the digester, on a pipe attached to the seal, and Figure 6 shows the corrosion damage on the inside of the seal. A voluminous black deposit containing a large amount of sulfur was found to cover the corroded steel surface. Table 7 shows the results from using SEM/EDS analysis on the deposits.

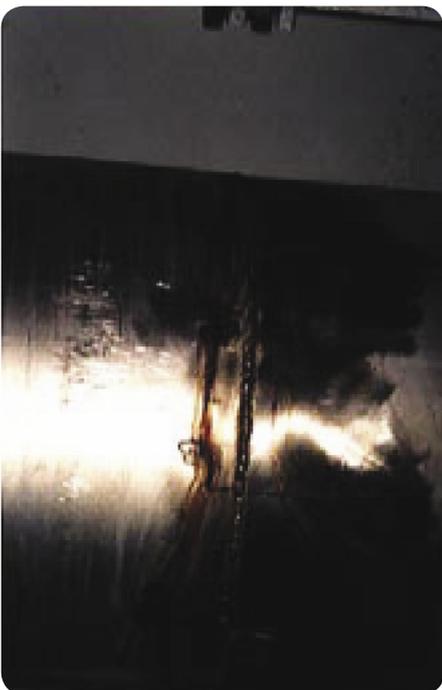
**Fig. 7** Corroded Type 316 Stainless Pipe with Corrosion Product from Corrosion Attack on the Circumferential Weld.
