## The Suitability of Stainless Steels for Road Constructions

# The Suitability of Stainless Steels for Road Constructions

Jan Olsson<sup>1</sup>, Arne Bergquist<sup>1</sup>, Anders Olsson<sup>1</sup>, and Bror Sederholm<sup>2</sup>

## Abstract

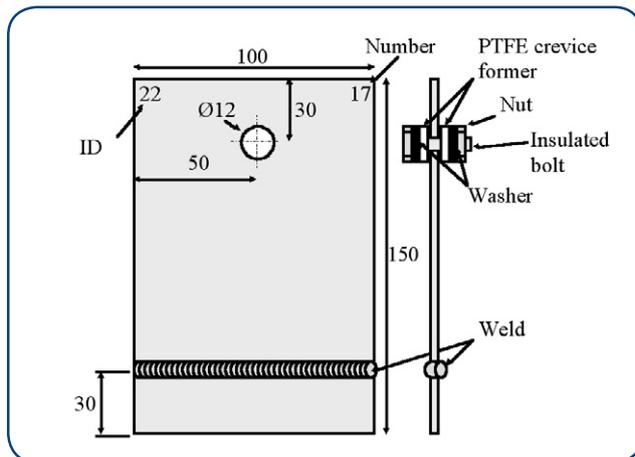
**Fig. 1** Welded specimen with crevice former.

The study has also covered specimens with different surface finishes, Table 2, welded, grades 201, 316L and LDX 2101, and non-welded specimens and specimens with and without crevice formers, Figure 1. The welding has been performed either as TIG (tungsten inert gas) or MMA (manual metal arc) with recommended welding consumables [1]. Post weld cleaning by pickling in mixed acid for 316L and LDX 2101 and mechanical cleaning for 201 (brushed with Scotch Brite). Temper rolled material (301) has been tested with 90° bends and as Hex-A-Beams®, Figure 2.

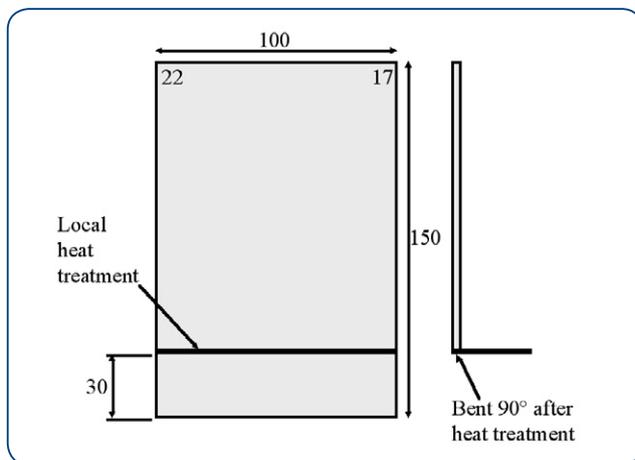
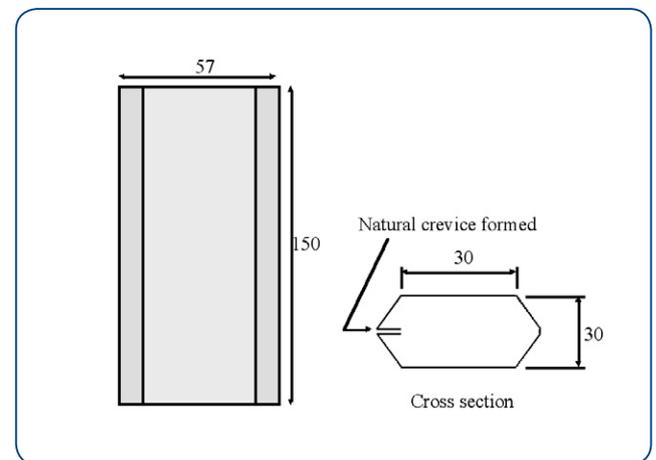
**Fig. 2** Specimens of temper rolled 301, 90° bends (left) and Hex-A-Beams® (right).

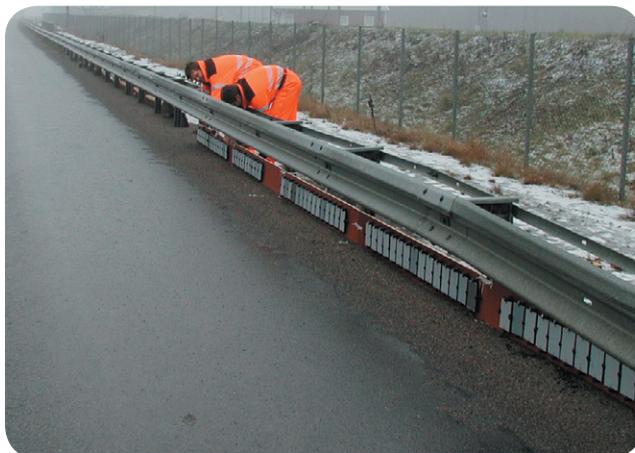
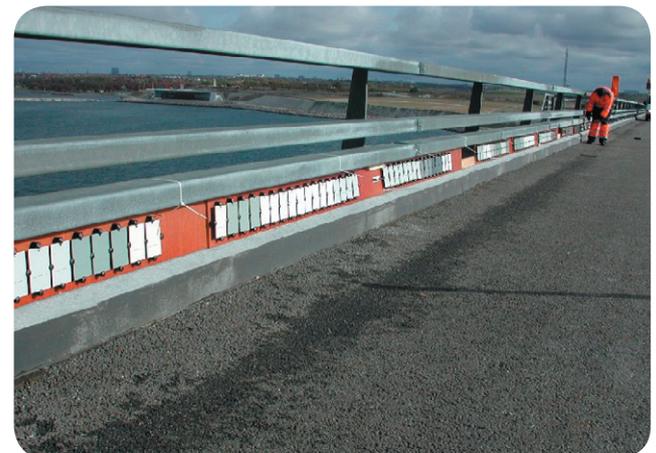
**Fig. 3** Plyfa sheets with specimens, Borås (left) and the Öresund bridge (right).

The specimens have been mounted on Plyfa sheets, which in turn have been mounted close to the roadway as shown in Figure 3.

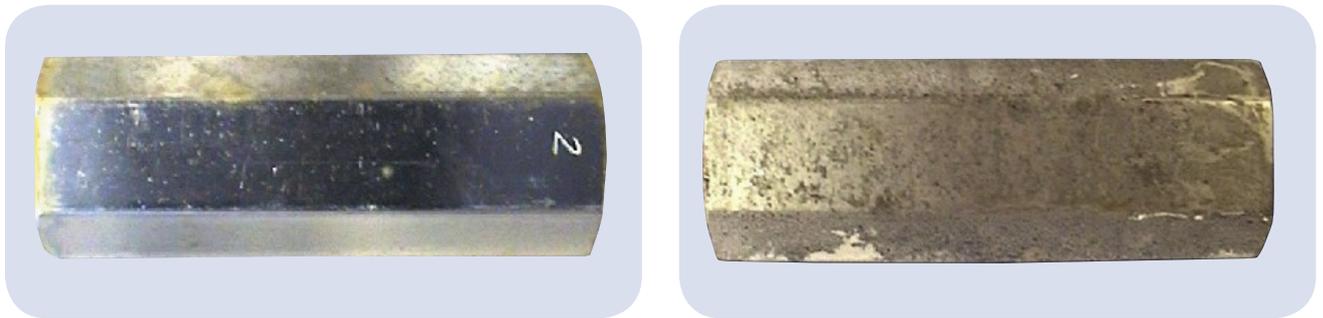
**Fig. 5** Hex-A-Beams® made of 301 after 2 years underneath the Öresund bridge (left) and inside the Söderledstunnel

The appearance of the least corrosion resistant material, 301, after exposure at the most hostile test locations, i.e. underneath the Öresund Bridge and inside the Söderleds-tunnel in Stockholm, is shown in Figure 5. The specimens have not been cleaned after the test.

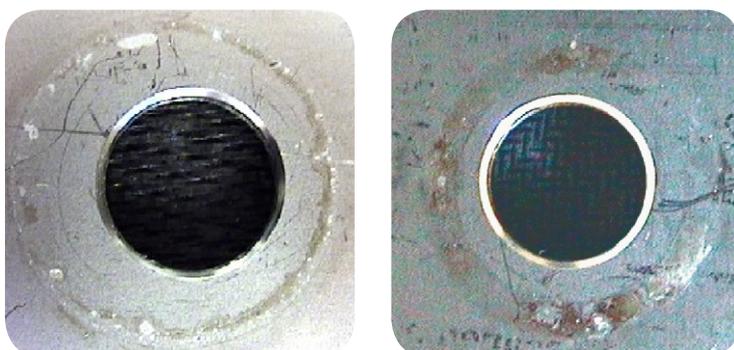
**Fig. 6** The most severely attacked specimens of grade 316L after 2 years exposure underneath the Öresund bridge (left) and inside the Söderleds-tunnel (right), showing crevice corrosion of 0.11 and 0.17 mm depth respectively.

A close view upon the specimens of 316L exposed at the same locations is shown in Figure 6. The specimens have been cleaned in order to facilitate the evaluation. Both specimens show some slight etching only due to crevice corrosion. The slightly deviating appearance of the tunnel specimen depends on some rust formation due to insufficient cleaning.

First of all, it should be established that when corrosion has occurred, it is very shallow. The maximum depth measured on any specimen is 0.17 mm crevice corrosion on 316L after 2 years of exposure in the tunnel, i.e. a penetration rate of less than 0.1 mm/year (< 5mpy). The extended testing time did not develop any deeper attacks, neither on this grade, nor on the others.

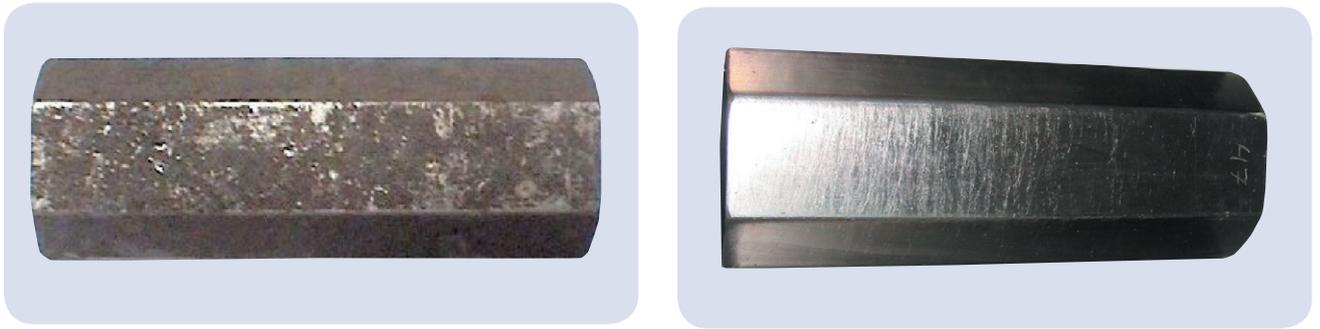
**Fig. 7** Hex-A-Beams® made of 301 after 4 years in the Söderledstunnel before (left) and after cleaning.

As can be seen in Table 5, the corrosion appearing on the three grades after the extended test time is still very shallow and could be defined more as a very slight etching considering a max depth of 90 µm after 4 years, i.e. about 20 mm/year or < 1 mpy, see Figures 7–10. The scratches are caused by gravel spray from the traffic.

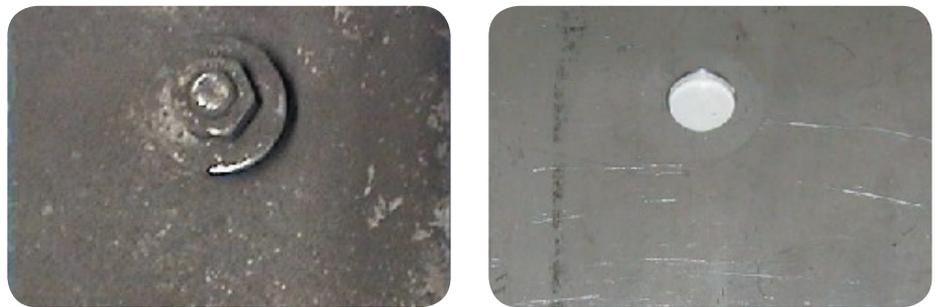
**Fig. 8** Specimens made of 316L after 4 years in the Söderledstunnel before (left) and after cleaning.

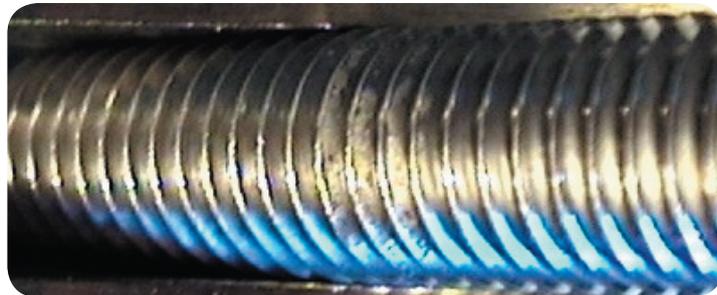
**Fig. 9** Bolt made of 316L with slight crevice corrosion on threads.

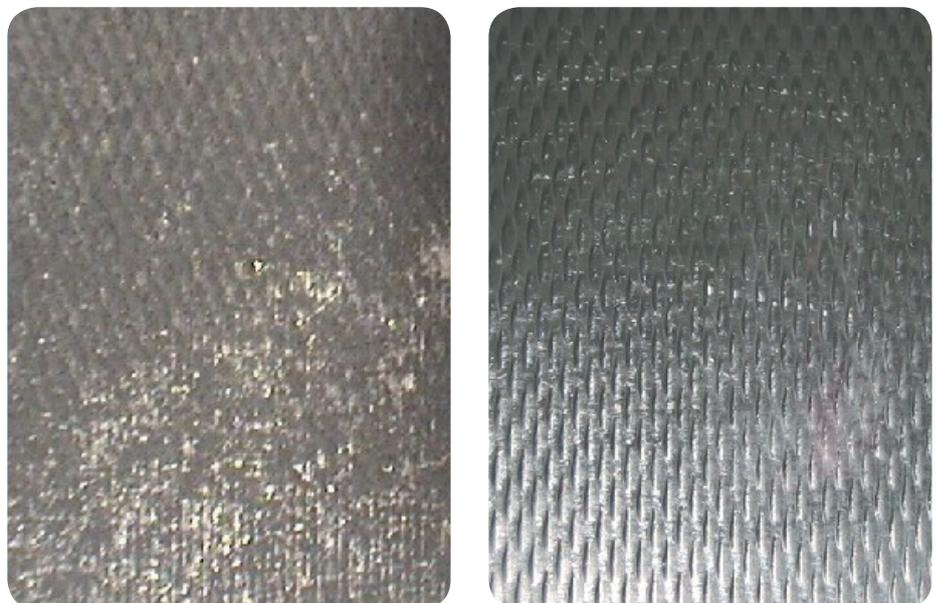
**Fig. 10** Pattern rolled 316L (high Mo) after 4 years in the Söderledstunnel before (left) and after cleaning.

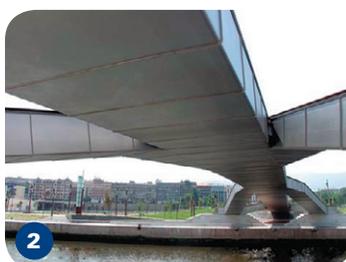
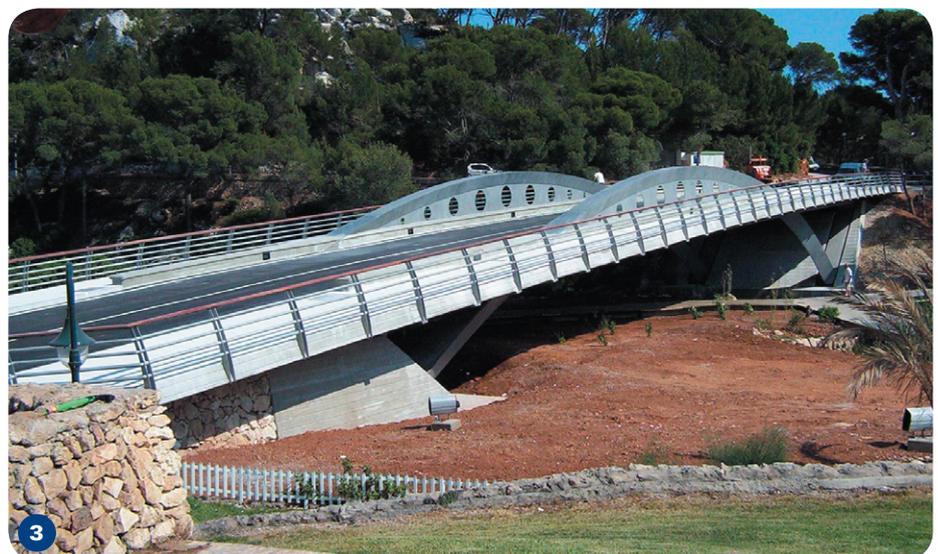
**Fig. 11** Bridges made of LDX 2101 (1), 2304 (2) and 2205 (3).

Solid stainless steel has during the last decade also become an option for the bridge itself. It should then preferably be made of duplex stainless steel to utilize the strength and the possibility to reduce gauge, weight and cost, Figure 11.

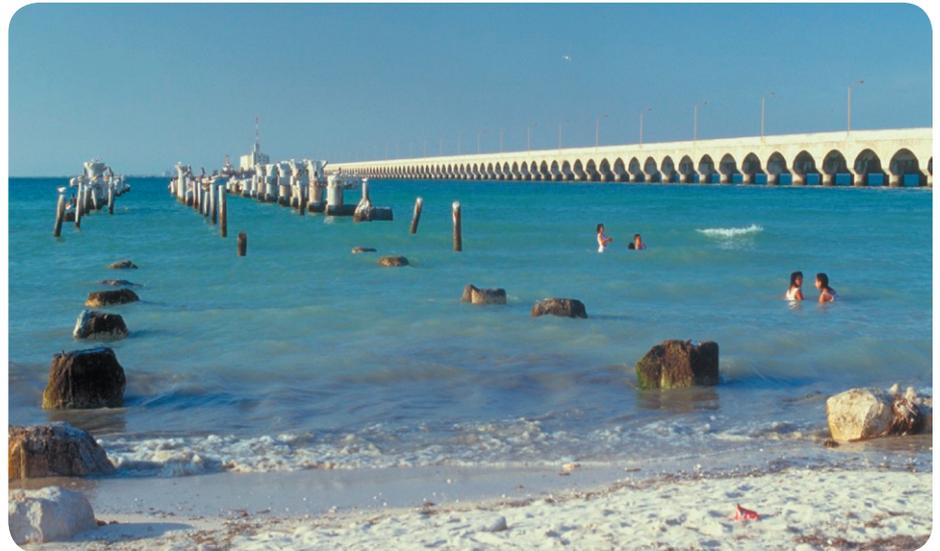
**Fig. 12** Remnants of a concrete pier with mild steel rebars after 32 years (left) and a still intact pier with stainless steel rebars after 60 years (right).

This was established by a comprehensive laboratory testing program reported at the annual NACE-conference in 2005 [6] and also clearly illustrated by practical service experience, Figure 12.
